massDOT
Massachusetts Department of Transportation

Attached for your review is MBTA Safety's Final Incident Report #A15-367. This involved an unintended train movement at Braintree Station on the Red Line on December 10, 2015.

GENERAL INFORMATION						
Incident Classification: Unacceptable Hazard						
Incident Description: Near Miss - Unattended Red Line Train Movement						
Date of Event: 12/10/2015	Time: 6:08 AM	Location: Braintree Crossover			Line: Red Line, Braintree Branch	
Route: #933, northbound		Weather Conditions: Temp: 45° F Wind: 3 mph Cloudy		Operator: David Vazquez (# [REDACTED])		
DPU Report #: 3787		Witnesses: 50 passengers onboard Train #1502		Instruction Department Determination: N/A		
Industry Safe #: FY15-4830						
Re-instruction: N/A		Discipline: Yes		Safety Investigator: Ronald W. Nickle Chief Safety Officer 857-321-3255 rnickle@mbta.com		
INJURY AND FATALITY INFORMATION						
Fatalities and Injuries	Employee	Passenger	Vendor/ Occupant	Pedestrian/ Motorist	Trespasser	Contractor

**Final Report #A15-367
February 26, 2016**

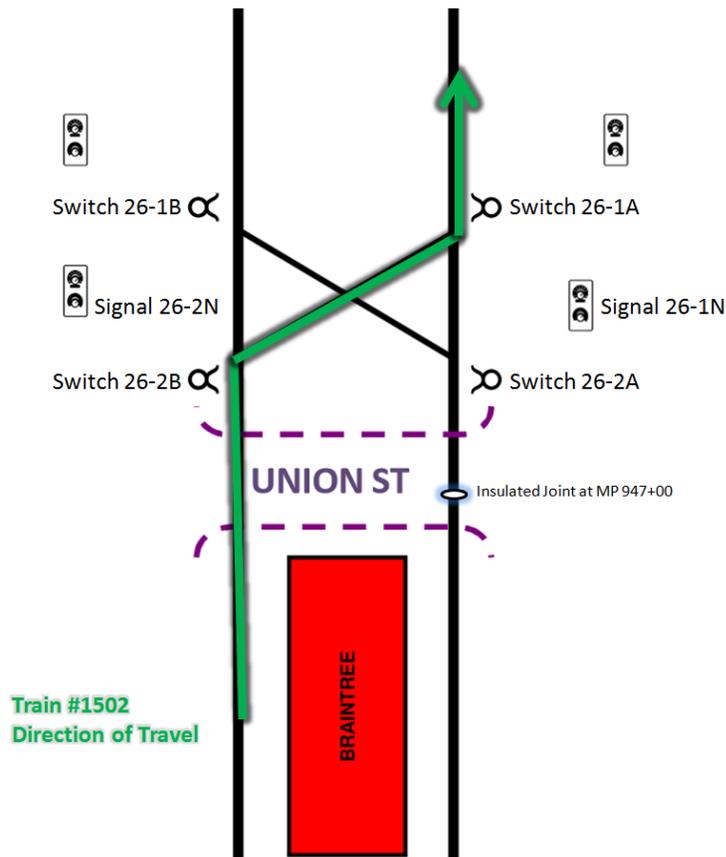
Track and Signals Diagram

1. At Signal 26-1N/Switch 26-1A, track conditions were found to be within MBTA Track Standards. However the following defects (determined non-contributory to the incident) were identified and resolved:

- b. Ties and tie plates were within track standards; however as an additional enhancement the track department has scheduled replacement.
2. At Switch 26-2A, track conditions were found to be within MBTA Track Standards. However the following defect (determined non-contributory to the incident) was identified and resolved:

- a. An insulated joint in proximity to the switch (MP 947+00) was found to be deteriorated and recommended for replacement. Prior to replacement, this insulated joint was tested by the Signal Department and was found to be within continuity and design limits. There is no indication that the insulated joint contributed to the intermittent code failures.

3. At Switch 26-1B, track conditions were found to be within MBTA Track Standards.
4. At Switch 26-2B, track conditions were found to be within MBTA Track Standards.

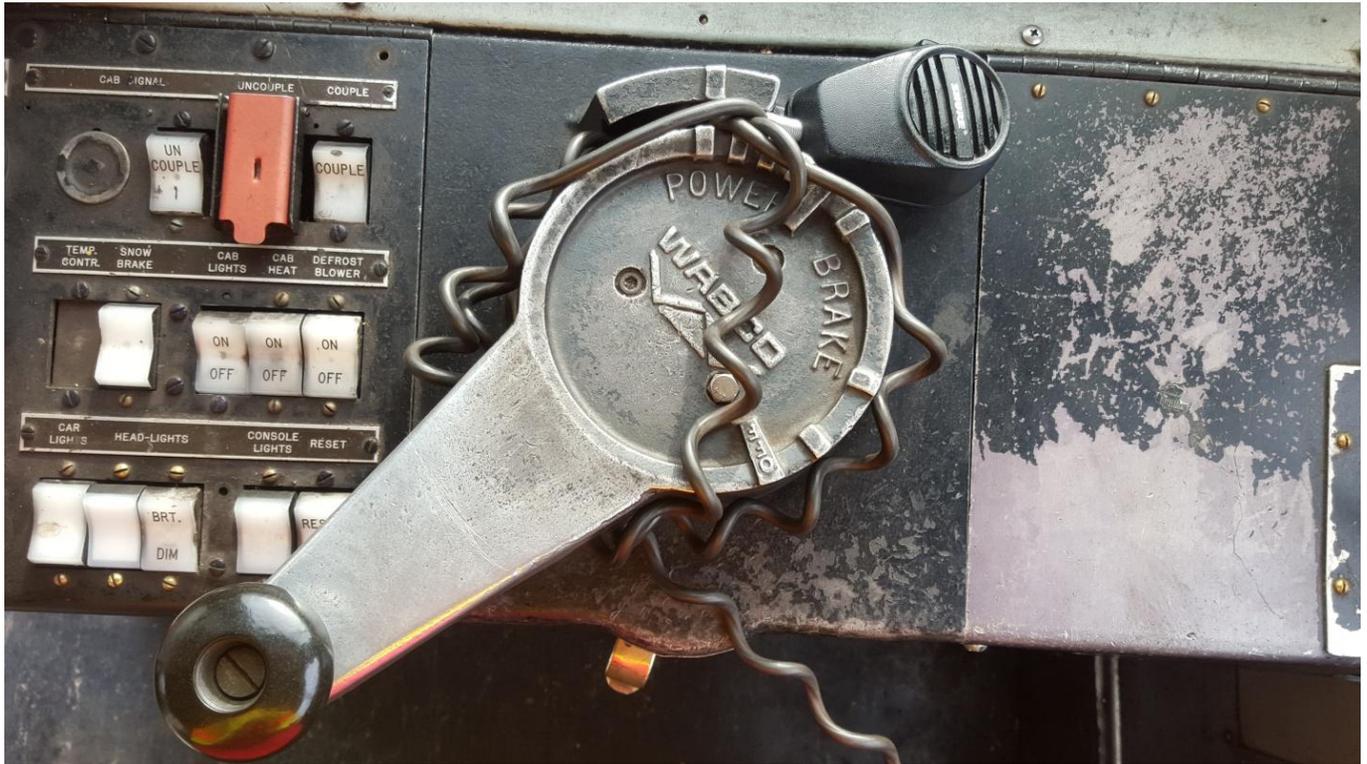
The probable cause of the incident resulted from the tampering with the deadman feature of the cineston in the control cab of Vehicle #1502. The method to inhibit the deadman was the use of the cab's PA microphone cord that was wrapped around the cineston control dial with the cord set between the dial and base plate indicator, with the cineston control set to the full propulsion mode. When the emergency bypass switch was activated, the train entered propulsion mode due to the tampered deadman feature. The train protection design in this mode restricts or limits propulsion to no greater than 25 MPH.

Figure 1. Cineston handle wrapped 2x's as described by responding personnel and customers with the dead-man feature activated (above view)

5. Determine the feasibility and cost/benefit, with consideration of vehicle age and replacement schedule, of redesigning and/or reconfiguring the cineston handle to remove, eliminate, or reduce the likelihood of tampering with, inhibiting, or disabling the deadman feature.

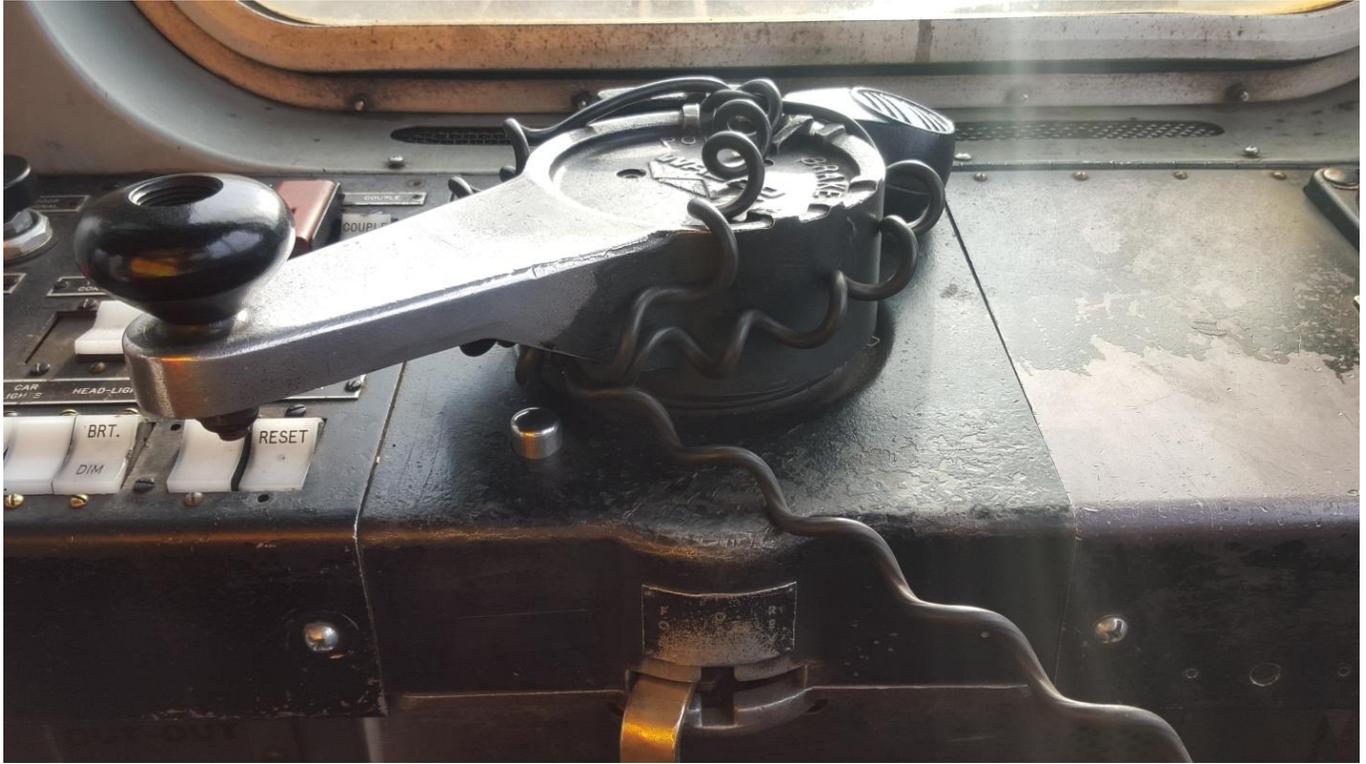
Figure 2. Cineston wrapped two times as described by responding personnel and customers with the dead-man feature activated (MP view). This is a recreation based on descriptions provided.

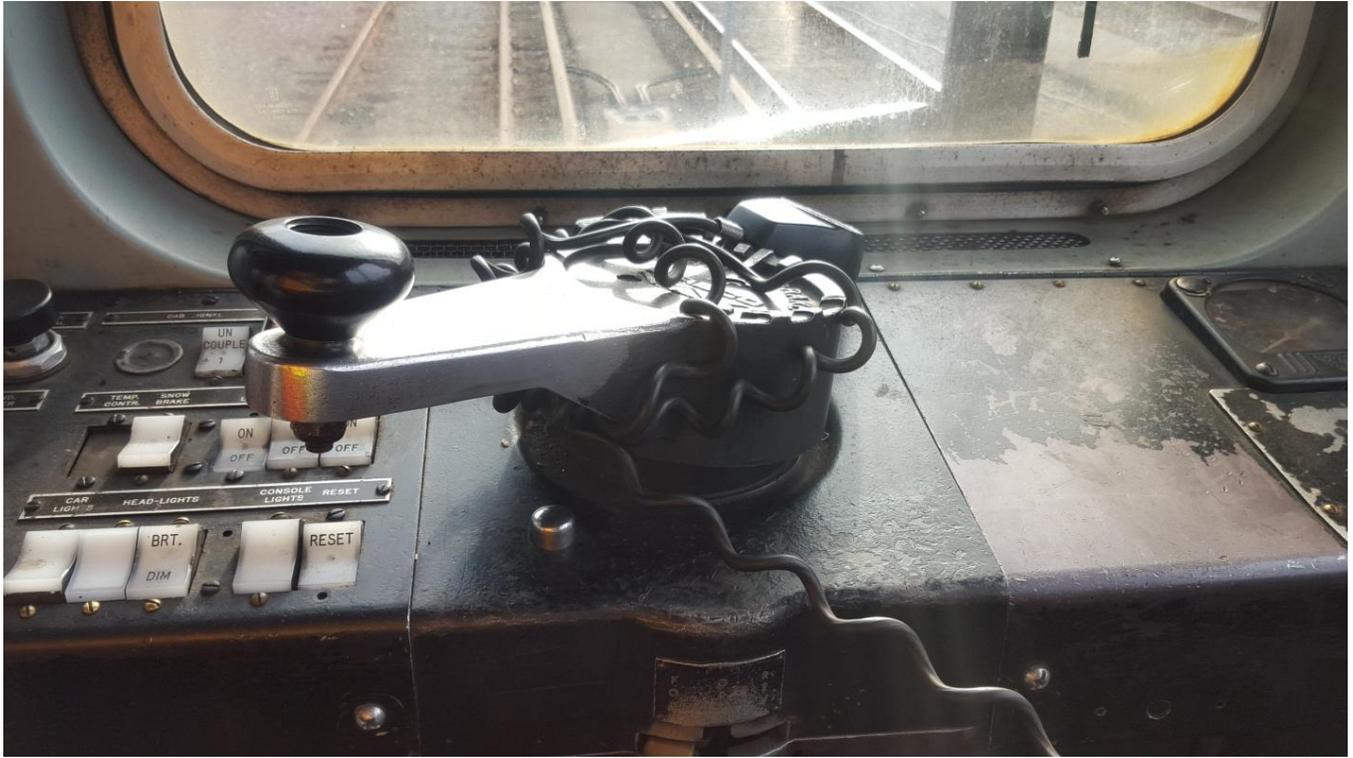
The investigation further surmises that inhibiting or tampering with the deadman feature or any other train protection safety device is an unacceptable violation. The deadman feature is a safety critical train protection system and violations of such protection is strictly prohibited, and based on the investigations findings, is the probable cause of the unattended train event.

Figure 3. Cineston wrapped 2x's dead-man feature deactivated (MP view). This is a recreation based on descriptions provided.

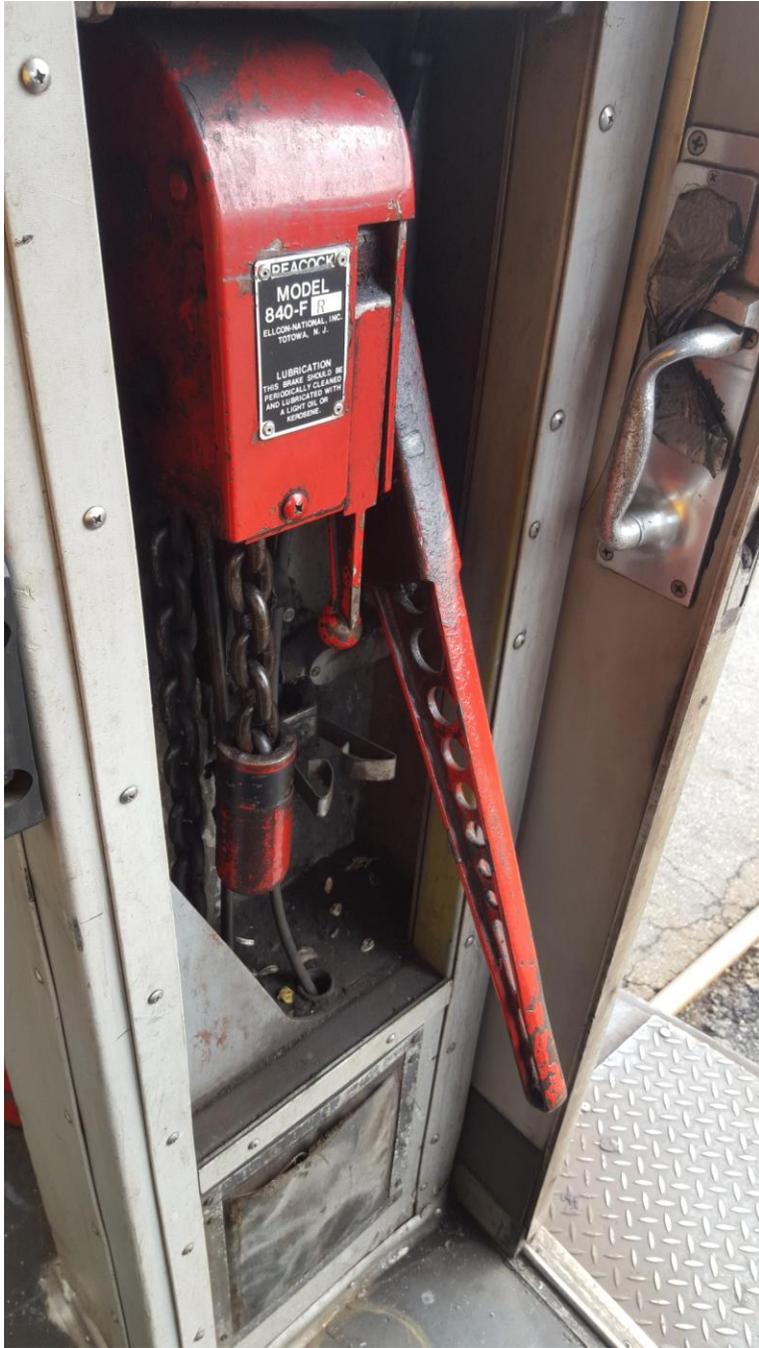
Figure 4. Red Line 1500 In-Cab Handbrake

The post incident test and inspection confirms the viability and functionality of the hand brake train protection safety capability. The investigation analysis therefore concludes that the hand brake had not been set when the operator exited the operating cab, and is in direct violation of specified safety

1. A contributory cause of the incident was the failure to apply the handbrake on Vehicle #1502 before exiting the control cab pursuant to operational procedures. The train's ATP safety design restricts train propulsion with the hand brake applied.
2. The design configuration placement of the emergency bypass switch, on the outside of the cab, requires an unattended train condition during the duration of the procedure.
3. The design configuration of the cineston is such that tampering with or inhibiting the deadman feature can occur using readily available means or methods.
4. Prohibited tampering with a cineston is difficult to observe due to sight limitations between stations in the subway environment and location of the cineston below the window level of

3. Review, examine, and improve existing emergency bypass and handbrake procedures to eliminate ineffectual steps or redundancies.
4. Determine the feasibility and cost/benefit, with consideration of vehicle age and replacement schedule, of suitable technologies, such as CCTV monitoring, to continuously observe an operator's safety activities, safety performance, and adherence to safety critical rules and procedures, including whether the operator is engaged in any prohibited acts.
