Massachusetts Bay Transportation Authority:

Orient Heights Maintenance and Storage Facilities

Current and Future Vulnerabilities to Climate Stressors

August 24th, 2018
AECOM
1 Federal Street
Boston
MA 02110

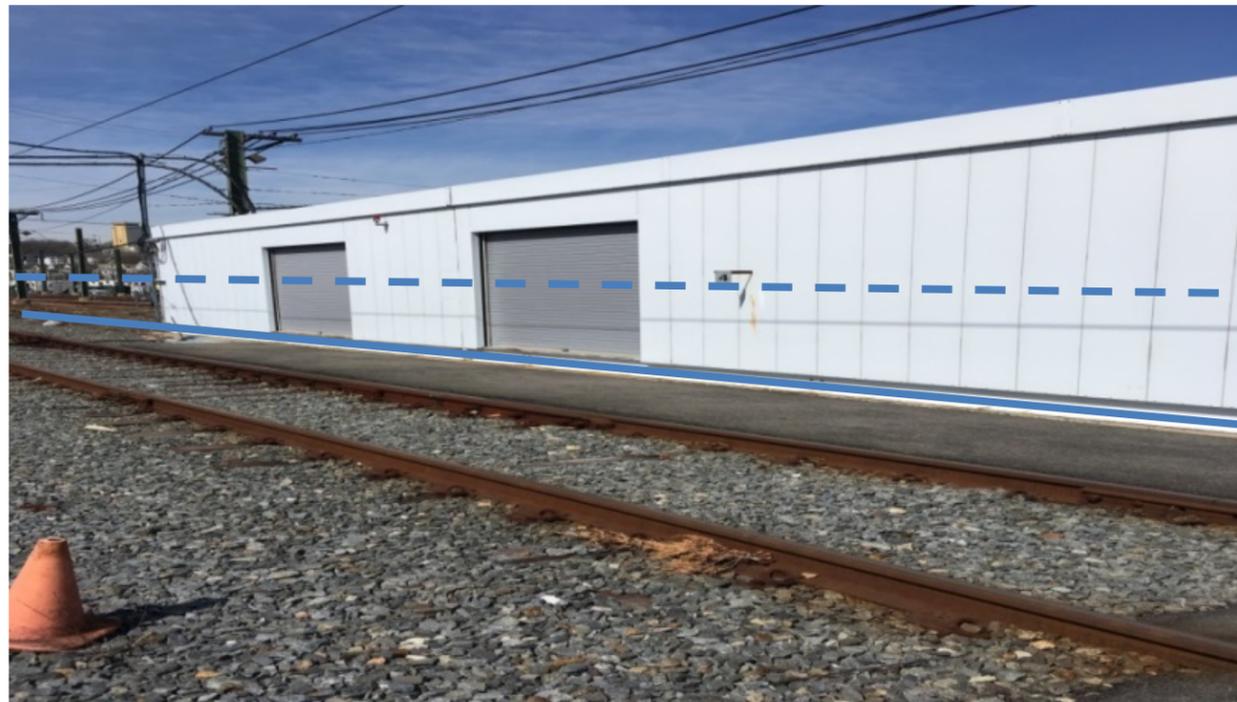
Figure 9: OH Car Yard Substation

Under the 2070 storm the unit power substation that powers the facility will be inundated with up to 4 feet of storm water, most probably rendering the electrical components useless and unable to be restored for the resumption of operations at the facility. Compounding that damage, the emergency backup power generator will also be inundated in the range of 3 plus feet and also be damaged beyond repair. Both primary and backup power sources will be rendered useless during the 100 year design event.

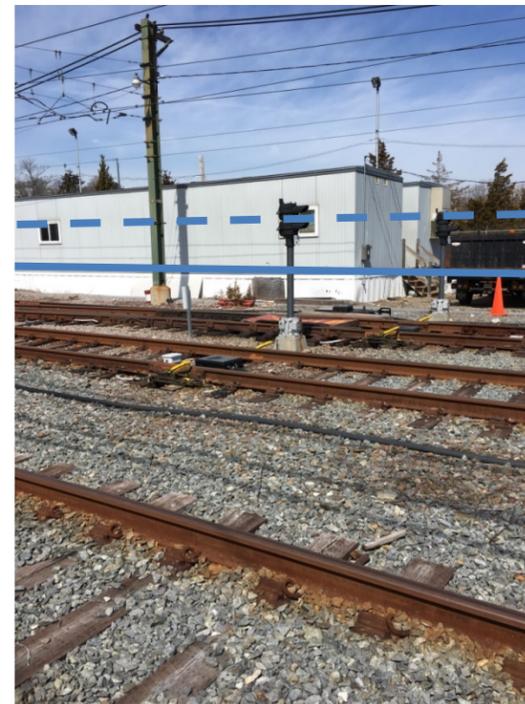
Figure 12: Maintenance Office Trailers

On the exterior, in addition to the critical electrical and security components already mentioned, the numerous temporary office trailers used by the maintenance departments were identified as a flooding hazard. Not only will the trailers and the power substations that serve the trailer complex be inundated by several feet of storm water, estimated upwards of 5 to 6 feet in depth, but these trailers will likely float during the storm surge and become floating debris that could cause consequential damage, such as blocking the tracks or access to the facility.

The on-site office trailers should be relocated to a raised berm above the predicted storm levels or replace them with permanent structures. Provide spare components for those equipment's, e.g. Wheel truing machine that cannot be relocated in the facility.

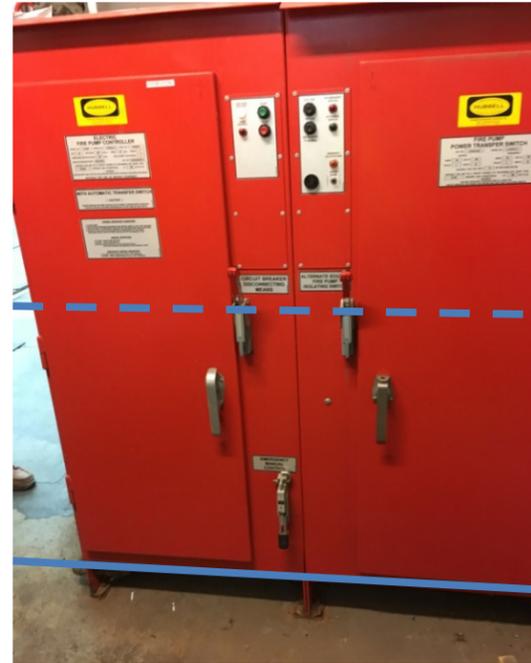
The perimeter security system and the control of the access gates will similarly be damaged by several feet of storm water, disabling perimeter security and likely disabling the control gates to enter the facility. In addition, the ability to isolate power both inside the building for facility, and traction power and on the exterior to control power to the outdoor catenary will be damaged beyond repair. The interior fire control and fire pump will be damaged, as well as the controls for all of the hoists within the building.

Figure 16: Building Systems – Fire Pump Control Unit

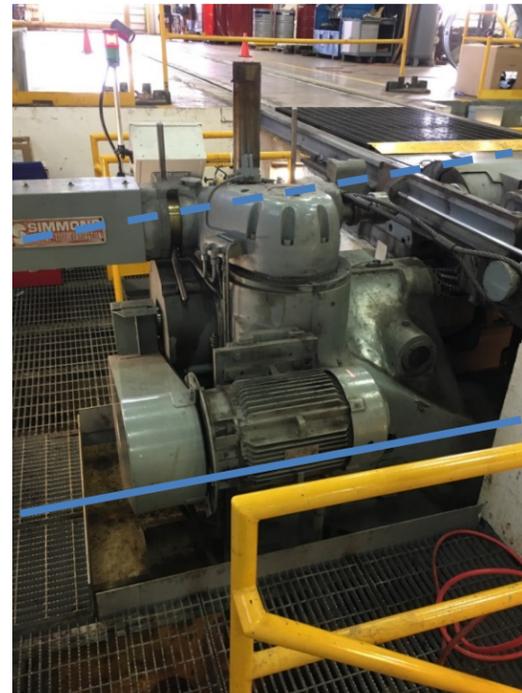
The wheel truing machine will be completely submerged and has to be assumed to be a total loss. Due to the nature of this piece of equipment in cannot be set at a higher elevation since it must rest below the vehicle. During the site visit and the interview with facility personnel it was reported that with the recent high storm levels this past winter storms of 2017-2018, some of the work pits, including the one with the wheel truing machine, experienced some flooding and the staff had to use emergency pumping to keep the water from damaging any equipment.

Figure 18: Maintenance Equipment – Wheel Truing Pit

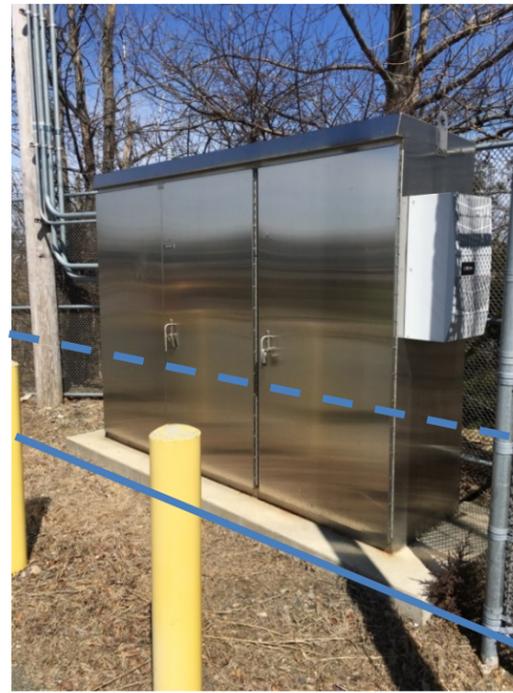
Figure 21: Security Controllers (3)

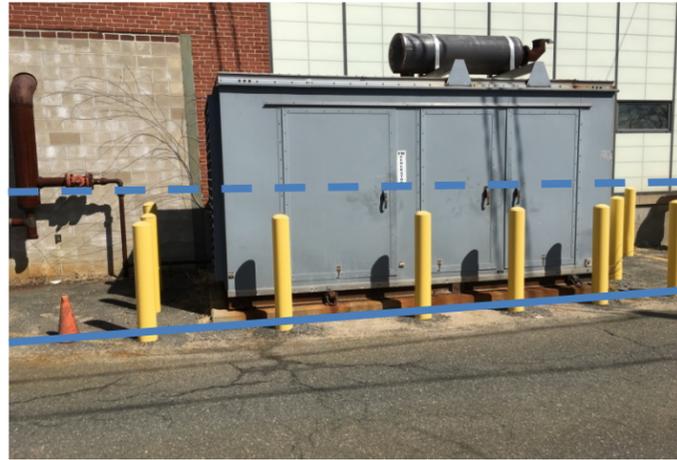
Figure 24: Building Systems – Emergency Generator
