Massachusetts Bay Transportation Authority:

Orient Heights Maintenance and Storage Facilities

Current and Future Vulnerabilities to Climate Stressors

August 24th, 2018
AECOM
1 Federal Street
Boston
MA 02110

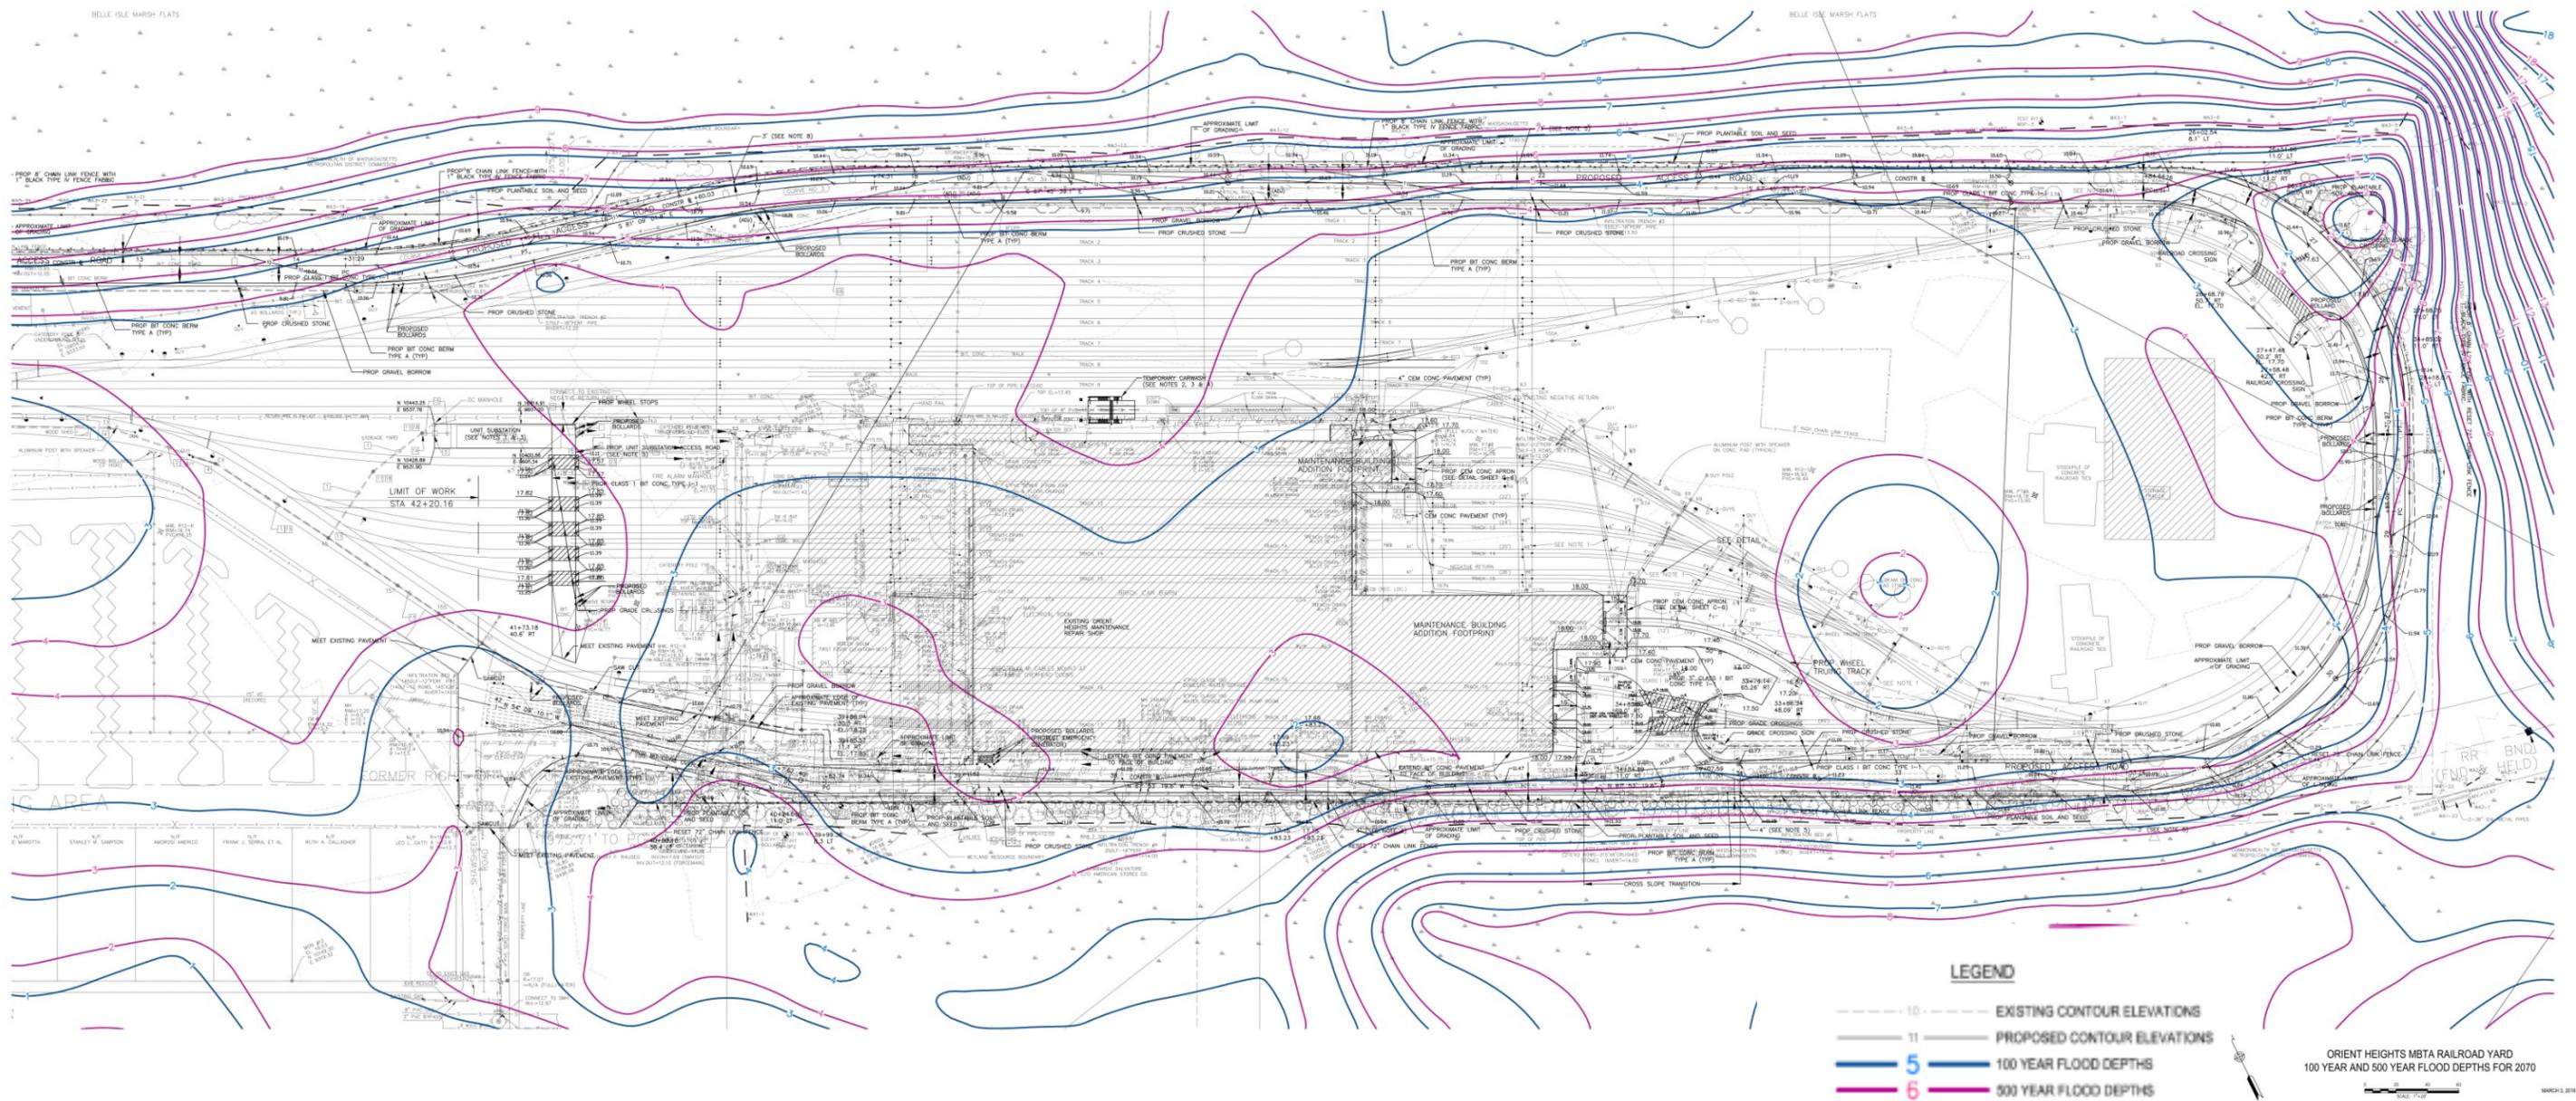
Figure 4: 2070 Inundation Depths 100 Year and 500 Year Recurrence Interval

It is apparent that during the year 2070 predicted storm event, the facility could not continue to function. Therefore, the focus of this evaluation turned to identifying those key assets that would inhibit the quick recovery of the facility once the flood had receded. These assets; Life Safety, Power and Security are discussed further in Section 3 of this report.

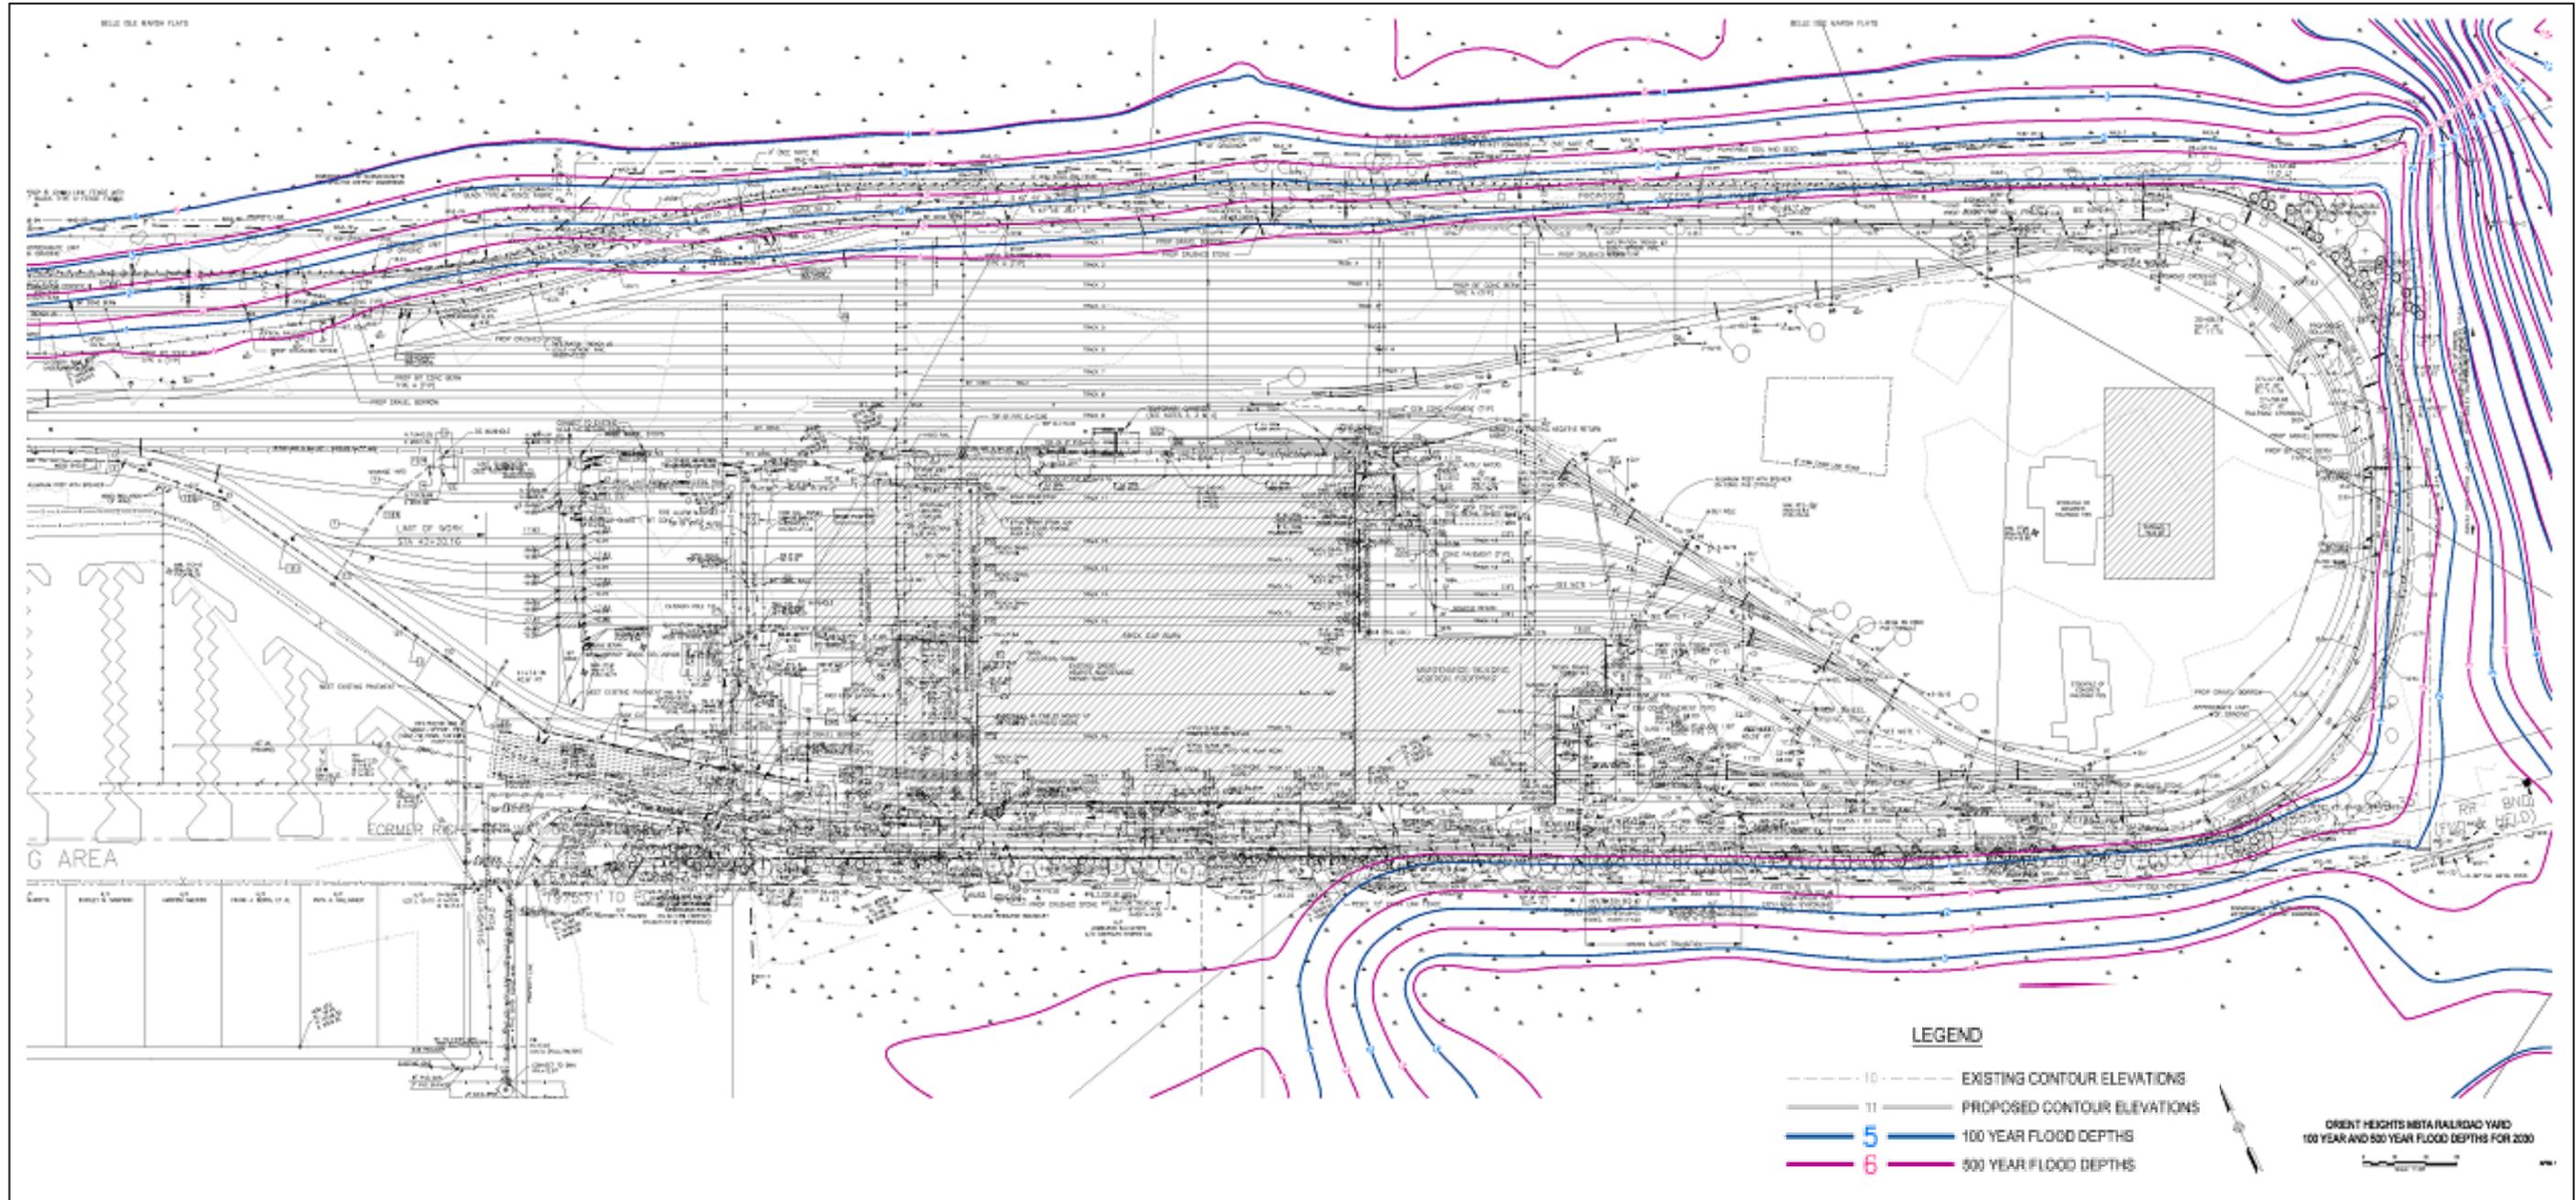
Figure 5: 2030 Inundation Depths 100 Year and 500 Year Recurrence Interval

During the 2030 predicted storms the inundation depths were less, and for the most part, did not reach to the Maintenance Buildings. For both 100 and 500 year predicted recurrence frequency, flood waters still did encroach onto the OH Car Yard footprint, however flooding did reach some key components as well as the Maintenance Trailers and outdoor storage.

Overall, the analysis found that, with some investment, the Facility could function in a limited capacity during the 2030 storm scenario.

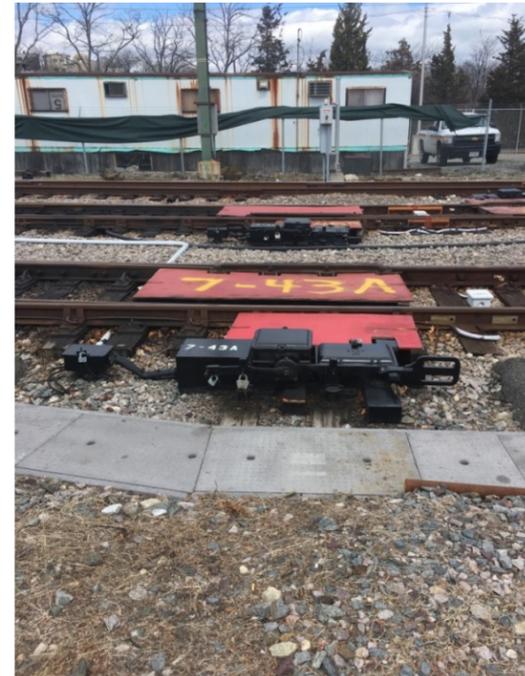
Figure 11: Blue Line Operations Signals and Power Switches entering the ROW

- Inundation can cause rail sensor failure, as well as other electrical failures (switches, gates, signals). There are also potential corrosive damages from salt. For example, metal and electrical components exposed to salt water from Hurricane Sandy are experiencing accelerated corrosion. MTA has seen long term deterioration of small gauge electrical connections (MTA, 2017).

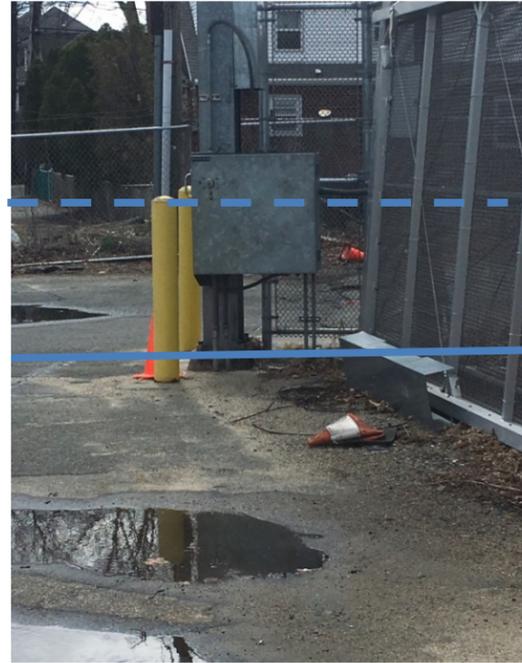
Figure 14: Security gate controller box

The perimeter security system and the control of the access gates will similarly be damaged by several feet of storm water, disabling perimeter security and likely disabling the control gates to enter the facility. In addition, the ability to isolate power both inside the building for facility, and traction power and on the exterior to control power to the outdoor catenary will be damaged beyond repair. The interior fire control and fire pump will be damaged, as well as the controls for all of the hoists within the building.

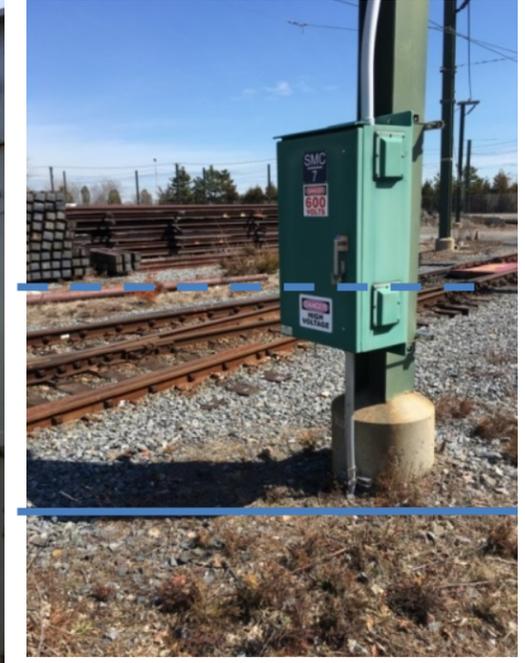
Figure 19: Blue Line Operations Yard Catenary Controller and Disconnect Switch

- Subsurface ventilation systems could be inundated in a flooding event, with the possibility of corrosion if exposed to salt water.
 - In flooding events, catenary poles may be damaged by debris carried in the water. Additionally, moving water may damage earthen supports for poles. If any catenary lines are exposed to saltwater, they may experience corrosion.

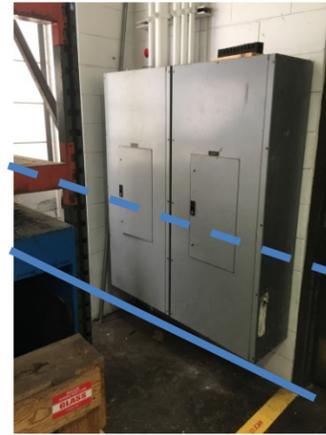
Figure 23: Maintenance Equipment – Hoist Breaker Panel

Int. 600 VDC Disconnects	27	3	0	Reset Int. 600VDC disc., min. 4 ft. above floor	Medium
Maintenance Trailers	12	5-6	2-3	Relocate Trailers or Replace with Perm. Structure	High
AC Power Feed Trailer Park	13	5-6	2-3	Relocate AC Power Feed Trailer Park	High
Wheel Truing Machine	18	4	2-3	Cannot be relocated, Provide Spare	Medium
Signal Bunglow	20	3	0	Reset Signal Bunglow, min. 4ft above grade	Medium
Security gates controller box	14	3	0	Reset box, min. 4ft. above grade	Medium
Hoist Break Panel	22	3	0	Reset Hoist Breaker Panel, min. 4 ft above floor	Medium
